UNITED STATES COAST GUARD

INVESTIGATION INTO THE STRIKING OF SUBMERGED
OBJECTS BY THE TANK VESSEL

ATHOS I

IN THE DELAWARE RIVER ON NOVEMBER 26, 2004
WITH A MAJOR DISCHARGE OF OIL

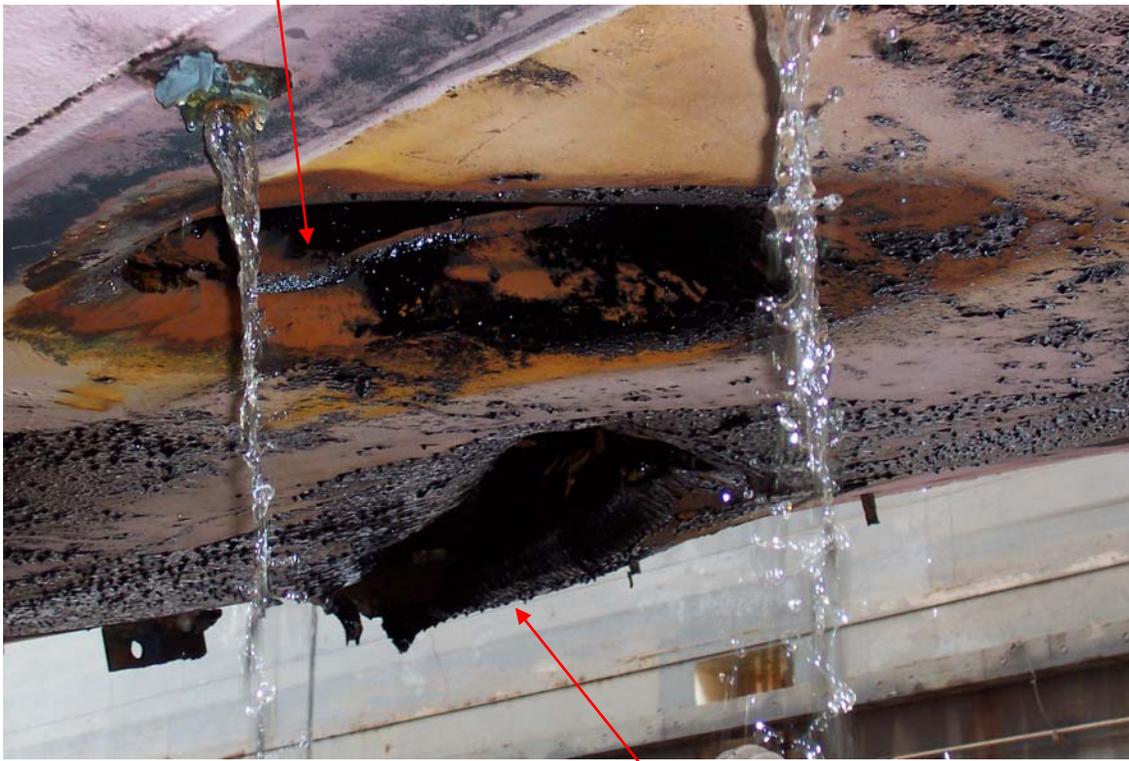
Semi-Circular Puncture

The puncture was located approximately 28" forward and starboard of the longitudinal slice. The puncture was semi-circular with a damage radius of 24" x 11" with hull damage flapped forward in a V configuration. This damage was located only in the #7 center cargo tank.

Main External Damage of the ATHOS I hull

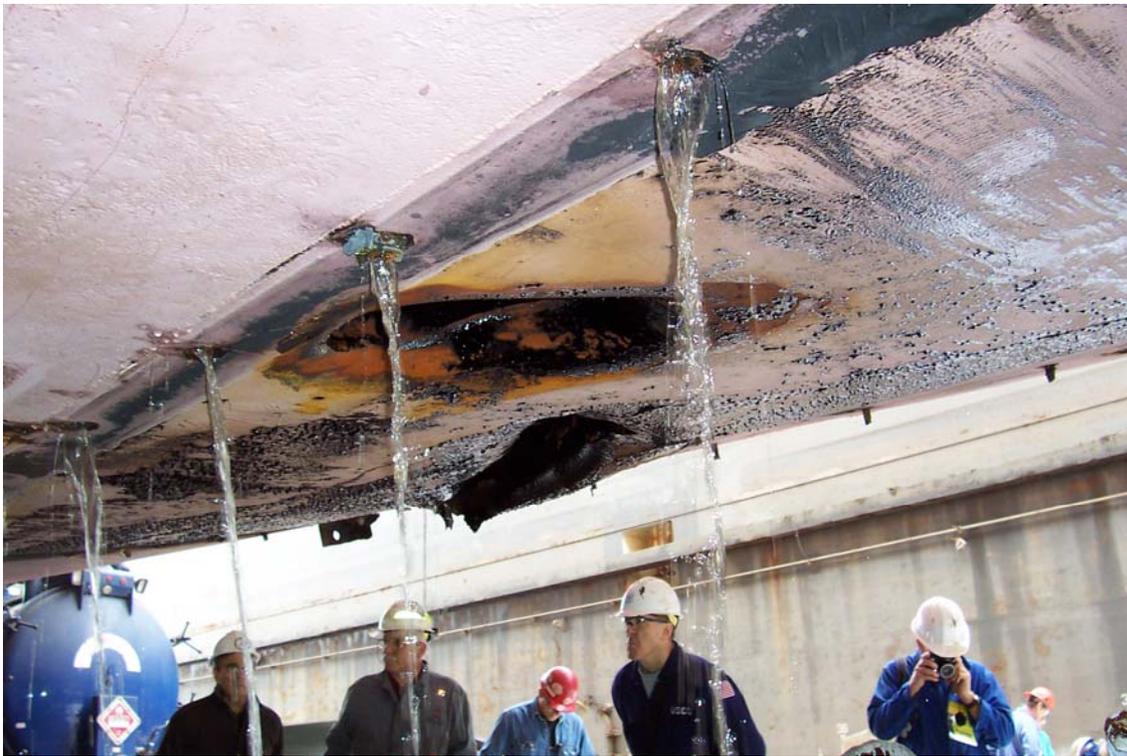
Longitudinal Slice

The longitudinal damage was approximately 63" long and was located in the #7 port wing ballast tank, extending into the #7 center tank by 2' on a 45 degree angle from outboard proceeding inboard. The width of the longitudinal damage was approximately 5" aft, with the center width at 9" and narrowing forward into the #7 center tank. Also found were contrasting directions of the fractured plating on both ends of the slice. Approximately 80% of the fractured plating flaps were pointed inboard, with the remaining 20% (at the opposite end of the slice) pointed outwards.

Main External Damage of the ATHOS I hull

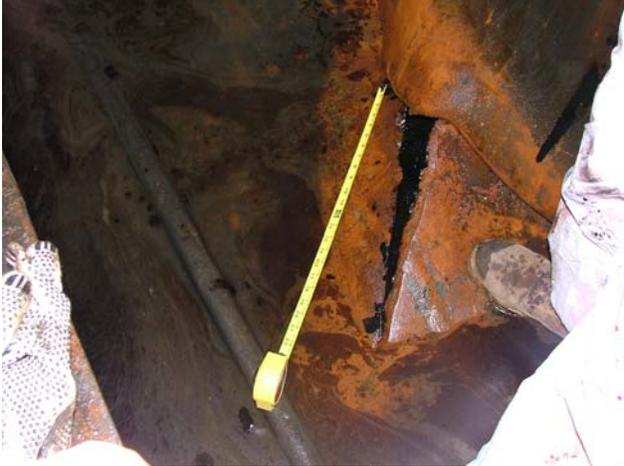
Longitudinal crack intrusion from the #7 Port Wing Ballast Tank into the #7 Center Cargo Tank. ** Viewed from inside the Tank **

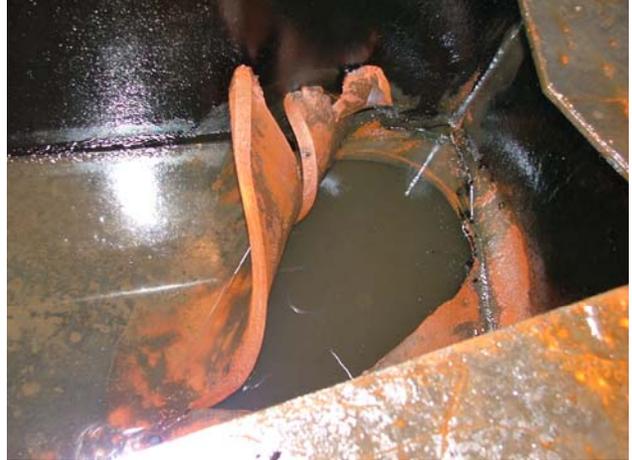
Puncture Damage located in the #7 Center Cargo Tank. ** Viewed from inside the tank **

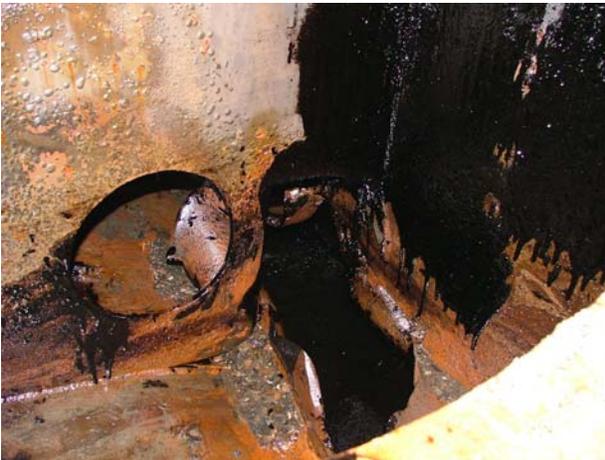
Damage located in #7 Port Wing Ballast Tank
** Viewed from inside the Tank **

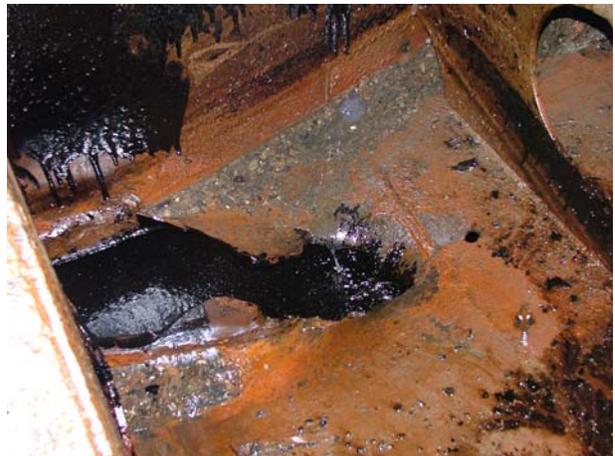
Damage located in #7 Port Wing Ballast Tank
** Viewed from inside the Tank **

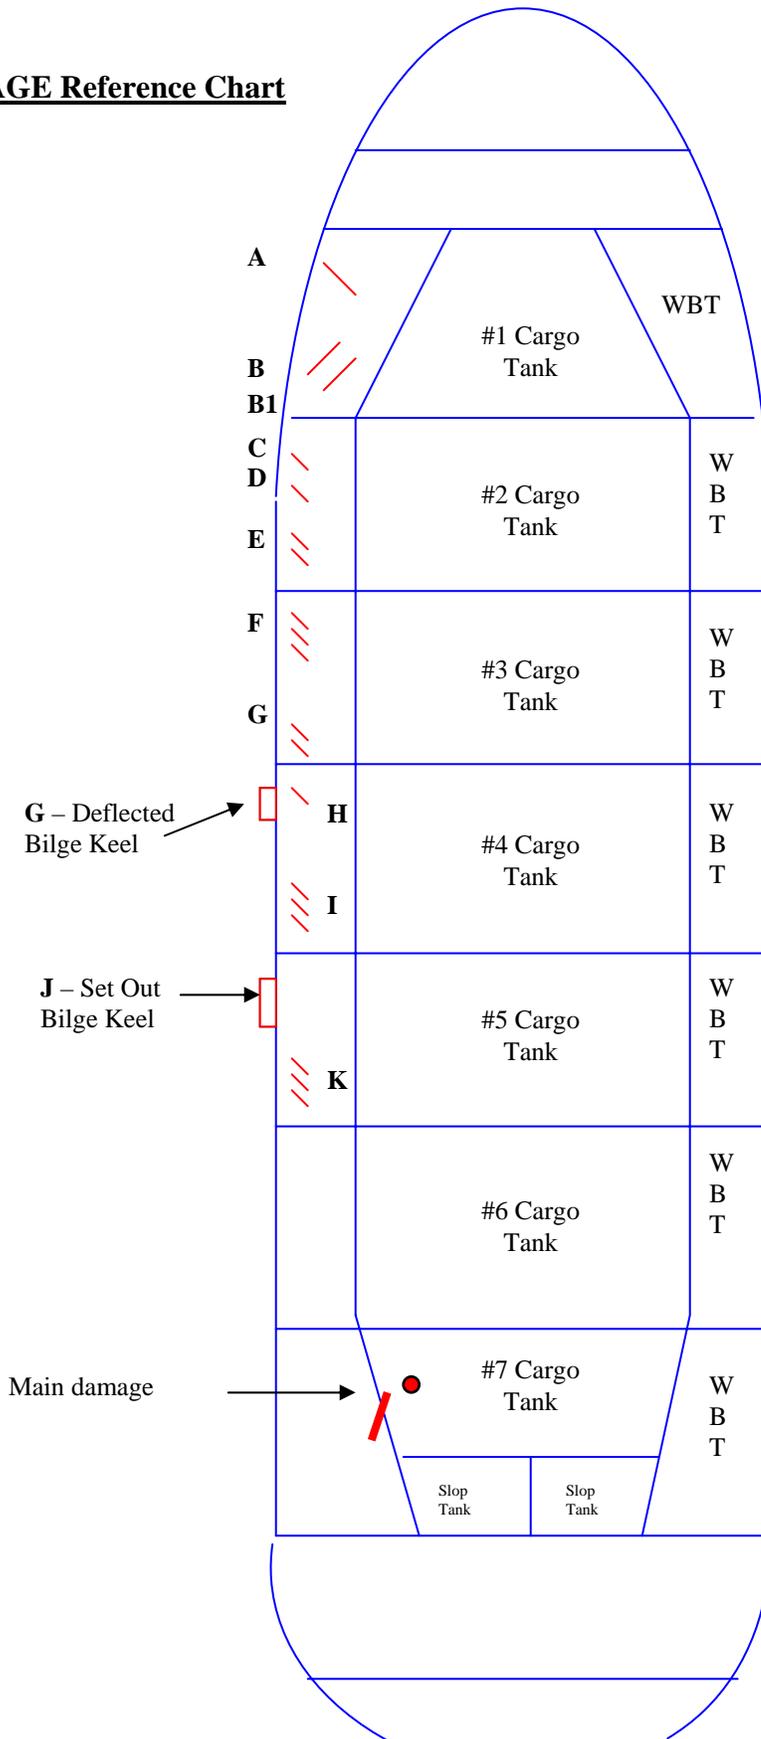
DAMAGE Reference Chart

Other minor hull damage locations (the reference diagram on the following page indicates locations of the damage marked as A through K):

- B.** Scrape approximately 7'6" in length, ranging from 1.5" to 3" in width. Vicinity of frame 86-85. 45 degrees off vessel centerline but perpendicular to damage at **A**.

- I.** Minor abrasions from the mid point of 4 Port WBT to 5 Port WBT. Vicinity of frame 69.
- J.** A more significant scraped area along with damage and a crack in the bilge keel. Bilge keel "set out" for a longitudinal length of approximately 18". Vicinity of frame 69.

Approximate location of damage shown in red. The previous pages describe the damage in detail.

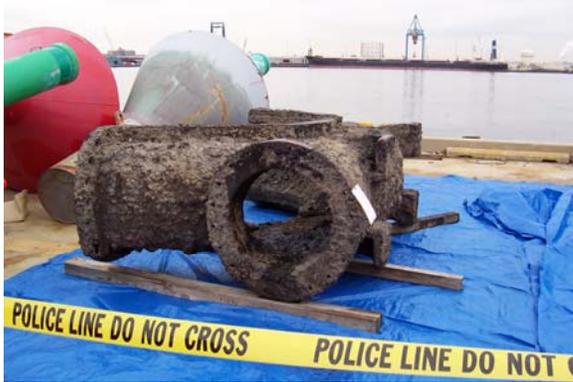
Pump Casing – On the 4th of December 2004 at 1421, Randive dove on an object that was discovered to be a pump casing at the following location - 39° 51.370 N, 075° 13.727 W. The pump casing measured approximately 12'6" long, 6'5" wide, and 3'5" high. The orientation of the pump casing at the time of discovery was parallel to the shore and on an angle, with the one side imbedded 1.5' into the riverbed and the opposite end (discharge flange) sitting on the river floor. A broken shackle was also discovered at the bottom of the discharge flange. At the time of discovery, Randive located a small area of paint that had rubbed onto the pump casing (top center & inside edge of curve on the pump casing,) and took a sample of it (sample # 01). Several notable metal scrapes were also found and located on the top portion of the pump casing. The most significant scrapes were located on the top footing closest to the discharge flange as well as on the top portion of the discharge flange. These scrapes appeared to be fresh with visible marks generally pointed in the same direction.

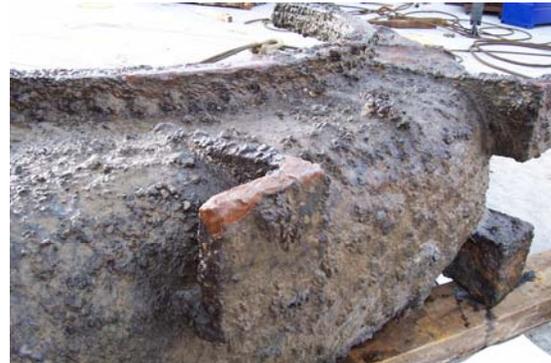
Close-up of the Pump Casing Footing

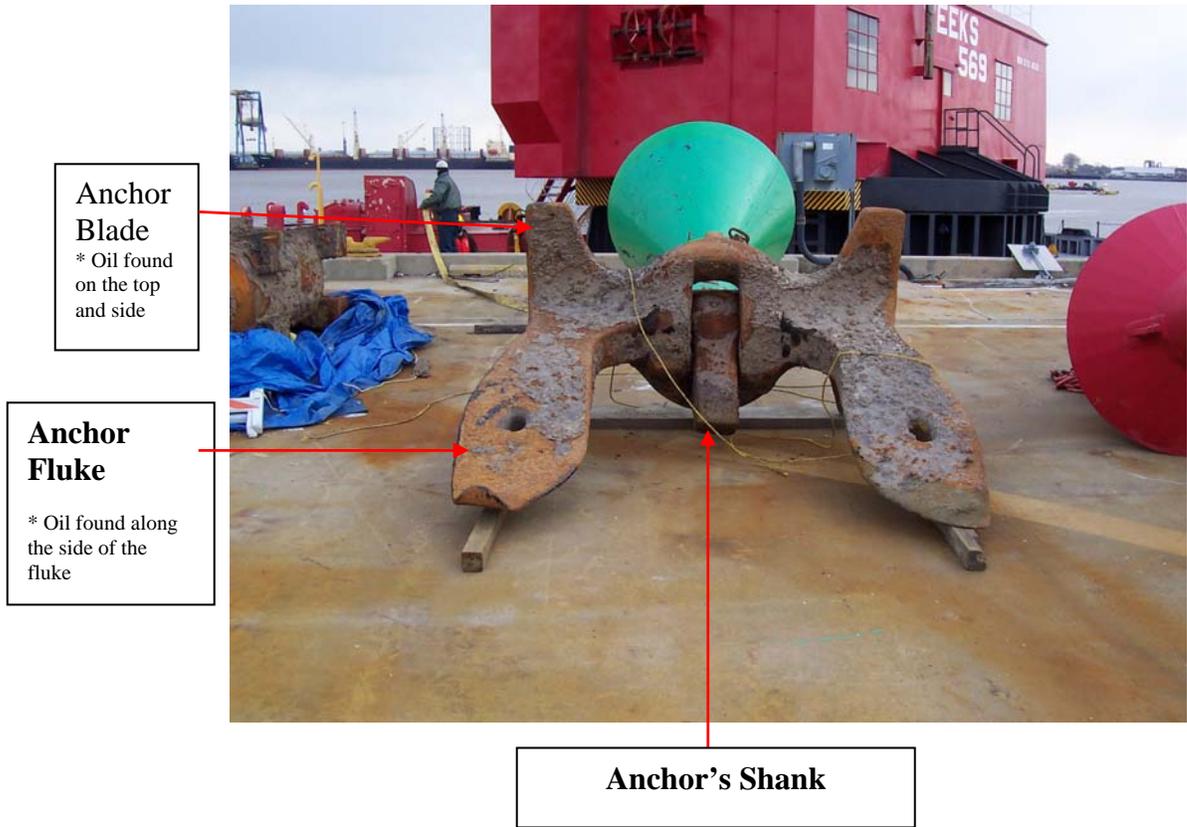
Recovered Anchor

On the 17th of January 2005, the anchor was recovered and transported to the MSO/Group Philadelphia pier. During examinations, fresh scrapings and a heavy coat of oil were found along the top and side section of one of the anchor blades (this section was later removed by MSO/Group Philadelphia personnel and sent to NTSB for analysis/comparison to other samples. Sample # ATHOS 1-006). Fresh scrapes along with heavy oil were also found on one of the anchor flukes, which was on the same side as the anchor blade with the scrapes and oil. Also at the end of the fluke the tip was bent upwards. No scrapings or oil were located on the other side of the anchor. The shank of the anchor was found to be missing; evidence suggests that a torch removed the shank.

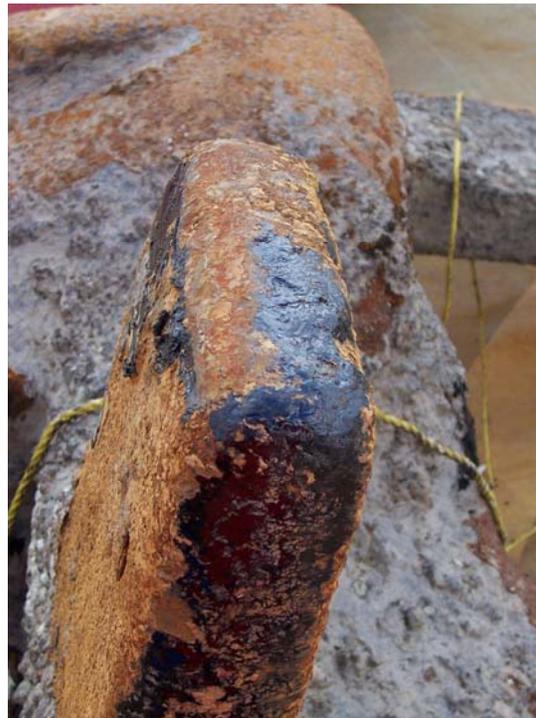
Close-up of Anchor Blade

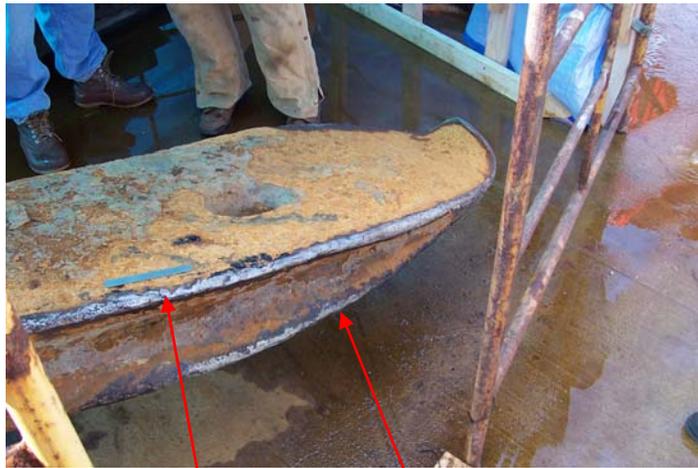
Anchor Fluke – notice the metal scrapes along the sides

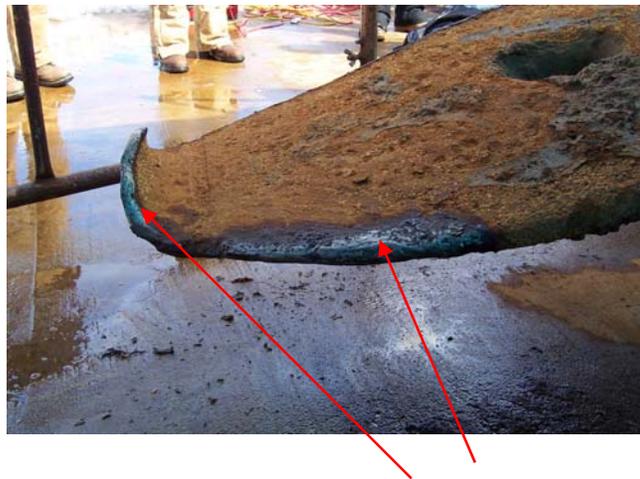
Anchor Fluke – with the bull bent upwards along with metal scrapes

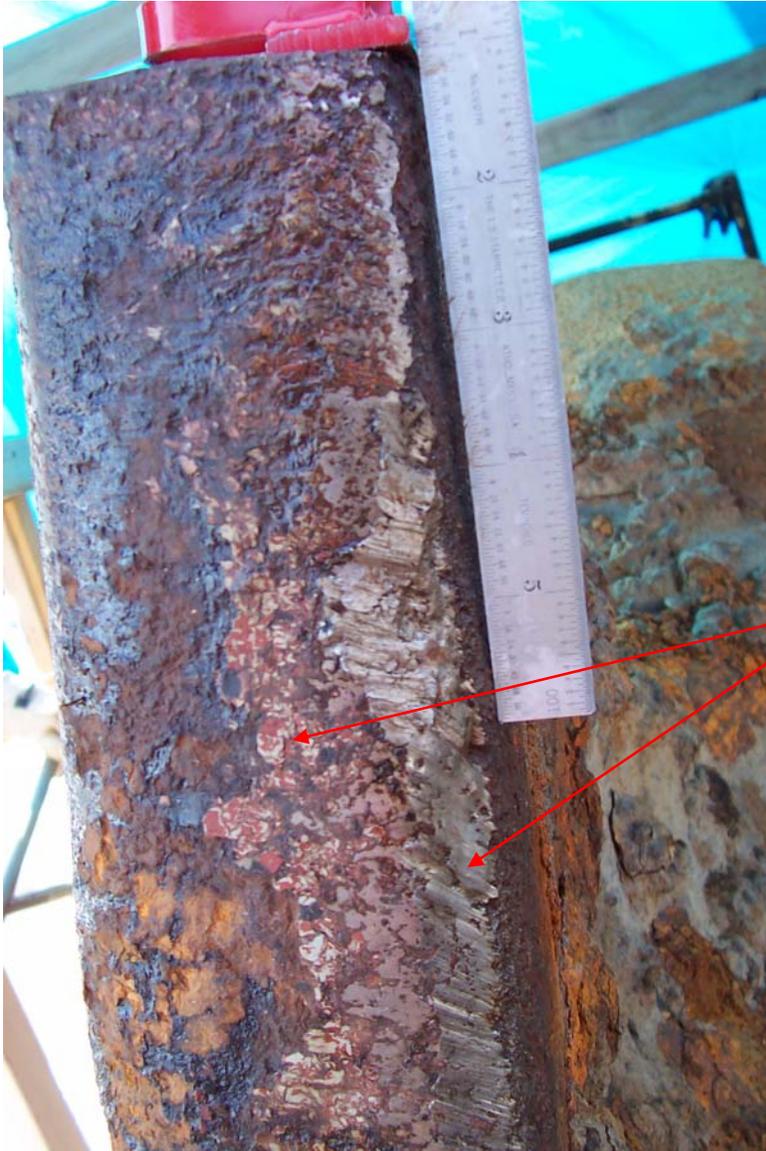
Anchor Blade –
showing the metal
scrapes and red
paint rubs.

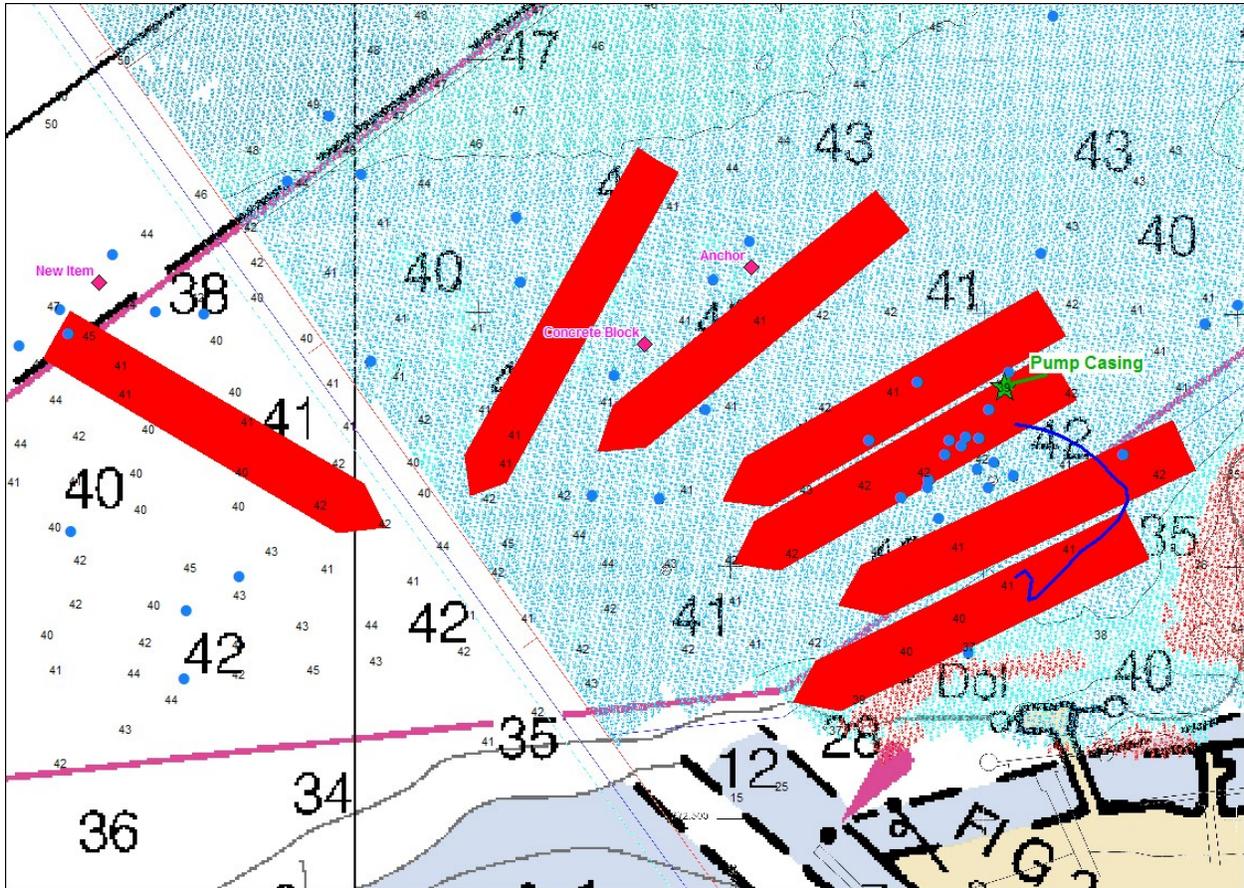
T/V ATHOS I locations related to submerged objects

NOAA (by request of Coast Guard MSO/Group Philadelphia) created a computer generated timeline/chart showing the relationship of T/V ATHOS I's location during transit to the submerged objects in Anchorage #9. NOAA used data taken from the T/V ATHOS I's echo depth sound recorder log to plot the course of the vessel on the chart. NOAA illustrated the concrete block and anchor as purple diamonds, while the pump casing was shown as a green star. Other submerged objects that were of interest but not proven to have allided with the vessel are shown as blue circles. Also represented is a large scour mark (discovered by AUSS) identified as a blue line.

Both charts show similar track lines of the ATHOS I with regards to the submerged objects. It is important to note the relationship of the anchor and damage location on the vessel. As can be seen from the track lines, there is a high degree of correlation between the exact location of the main damage on the vessel and the location of where the anchor was found. It is not known how, or exactly where, the anchor was lying on the river bottom before the ATHOS I struck it; however, it is probable that the anchor's original location was close by.

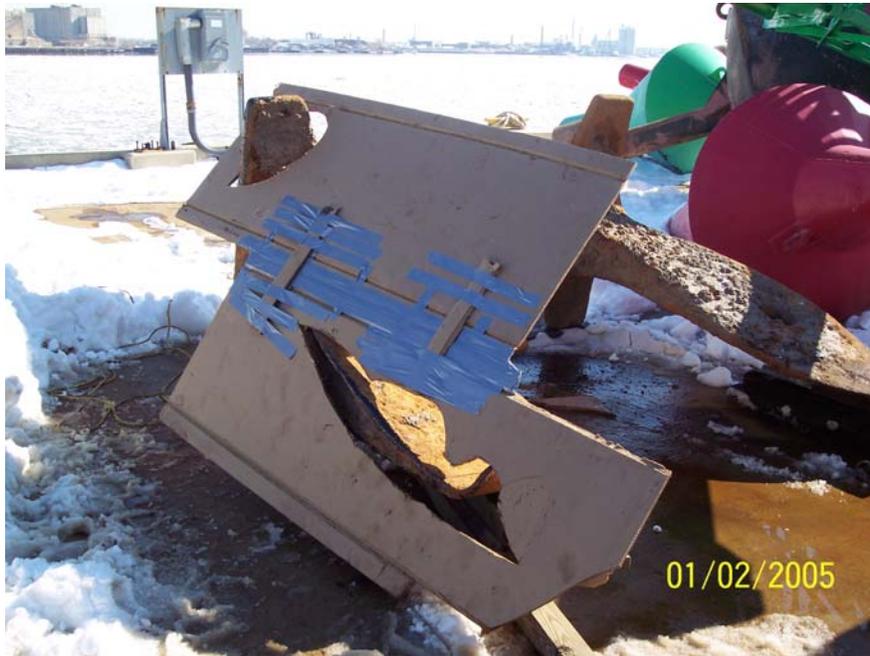
Figure 1- Cardboard Template

On the 1st of February 2005, experts hired by the owners of the ATHOS I, consisting of Mr. Tony Bowman (Naval Architect from TMC Marine Consultants) and Mr. Joseph Crosson (Metallurgist from Lucius Pitkin), along with Coast Guard Investigators examined the damaged hull section in detail and compared it to the recovered anchor's physical characteristics. Mr. Bowman and Mr. Crosson created a cardboard template of the hull damage by placing a plastic sheet against the hull and cutting an outline of the damage to the sheet. The outline on the plastic sheet was then transferred to a cardboard sheet and cutout. This cardboard template was then set to the anchor blade and fluke section (the same location of the scrapes and paint found on the anchor) for comparison. Figures 1, 2, & 3 shown below show the comparison between the template and the anchor blade. The comparison showed the anchor blade and fluke **matched identically** to the cardboard template.

Also, due to the nature of the main damage observed on the ATHOS I hull, specifically the inward and outward folds found in the #7 Port Wing Ballast Tank, it is highly probable that the anchor was lodged in the T/V ATHOS I hull for a brief period of time during the strike.

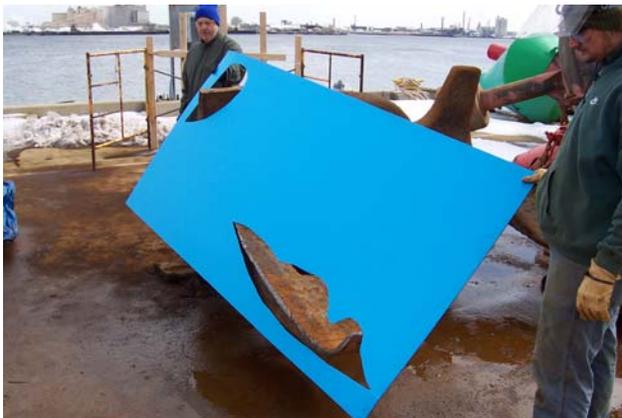
Figure 2 –Plastic Template

On the 2nd of March 2005, during cleaning operations performed on the recovered anchor, Mr. Joseph Crosson and his assistant made a more permanent template of the damaged section by transferring the cardboard template to a hard plastic sheet (shown below).
