*Feasibility Study*

# CONCORD RIVER DIADROMOUS FISH RESTORATION

PUBLIC MEETING | FEBRUARY 23, 2016 | NORTH BILLERICA, MA

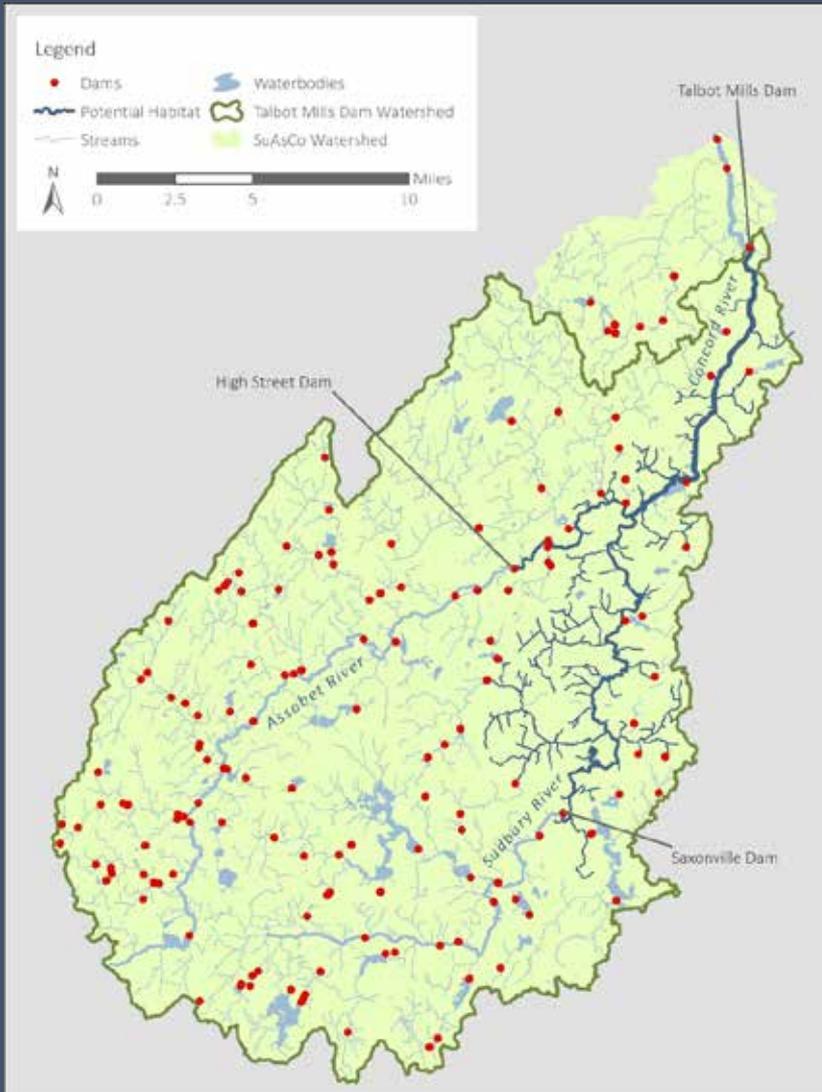
# WATERSHED – Potential Habitat

- Fish passage at Talbot Mills Dam would open access to:

- 35 miles (740 acres) of mainstem rivers
- 100 miles of tributaries
- 260 acres of lakes and ponds

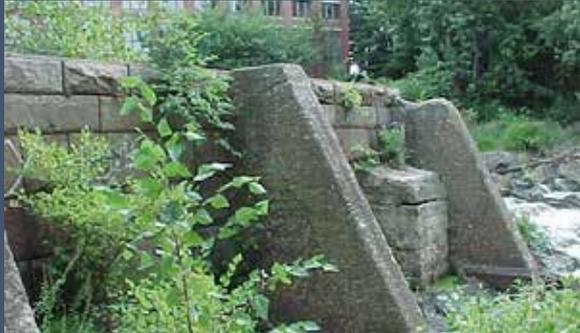
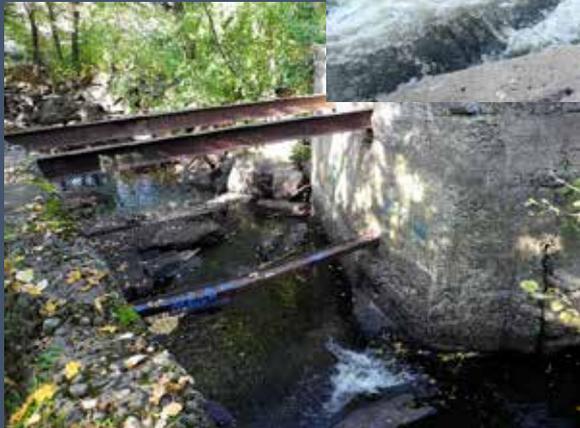
# OBSTACLES – Middlesex Falls

- Former Middlesex Dam (breached in 1980s)
- 2000 NRCS/USFWS survey
- Possible fish passage impedance at some flows
- Minor channel modifications may improve passage
- Potential use of former raceway channel

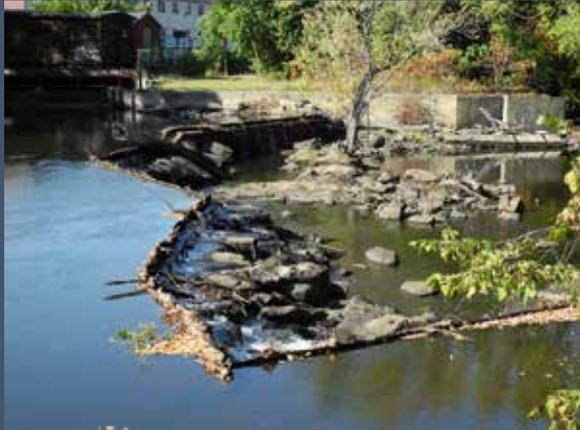
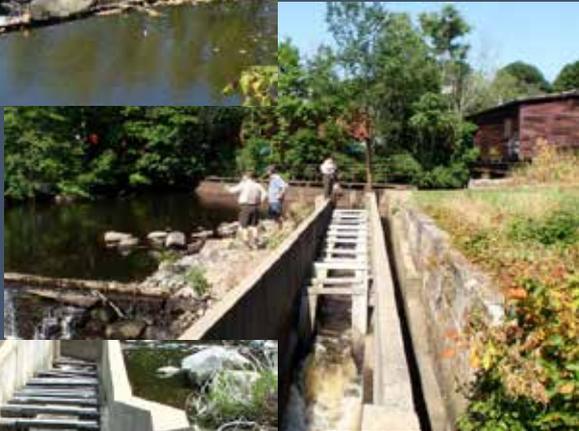
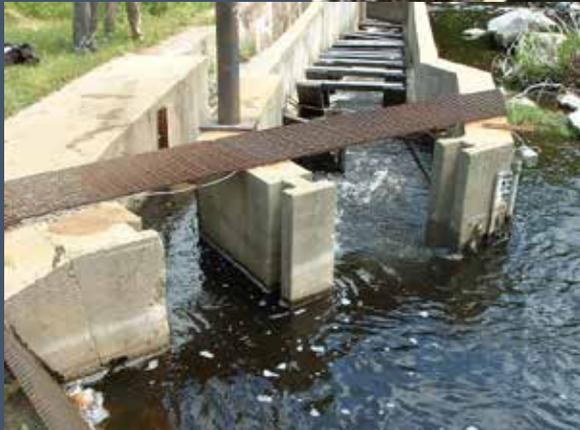
# OBSTACLES – Centennial Falls Dam

- 8-foot-high dam with hydropower (22-foot hydraulic head)
- Fish ladder & downstream bypass sluice added in 1990
- History of deficiencies
- More recent active management and coordination
- River herring observed in fish ladder in 2015

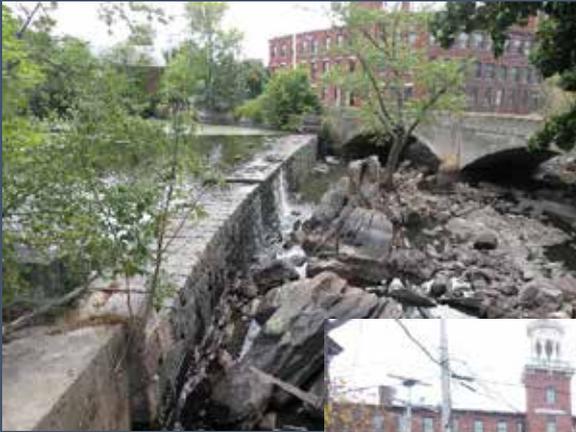
# OBSTACLES – Talbot Mills Dam

- 10-foot-high former mill dam
  - Primary spillway (127 ft)
  - Abutments
  - Non-overflow section
  - Former intake structure
  - Sluiceway
- Privately owned  
(CRT Development Realty, LLC)
- No current fish passage facilities

- 2015 inspection
  - Intermediate size, significant hazard, fair condition
  - Deficiencies:
    - Lack of operation & maintenance plan, routine oversight
    - Lack of working controls, low level outlet, emergency bypass
    - Seepage in the abutments
    - Trees below spillway and on embankment
  - Estimated repair cost: \$105,000+
- Feasibility study findings
  - Does not meet regulations to pass spillway design flood
  - NOT a flood control dam

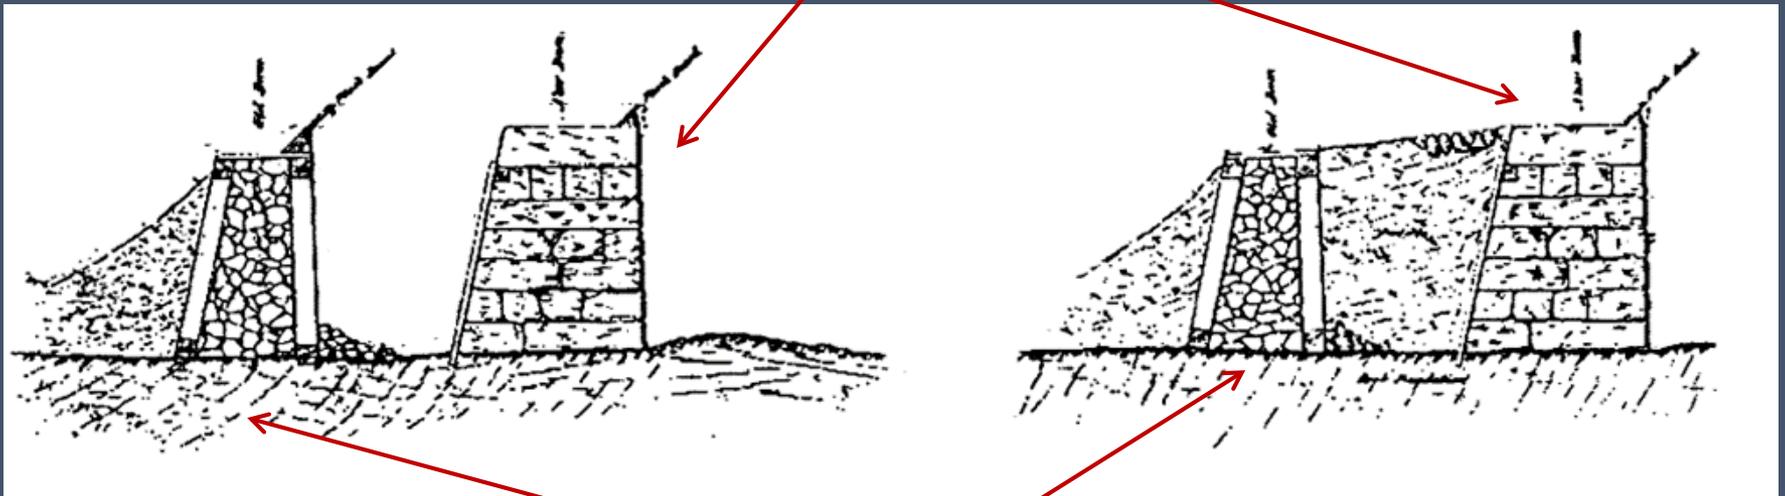
Current (1828) dam

1798 "legacy dam"  
submerged upstream

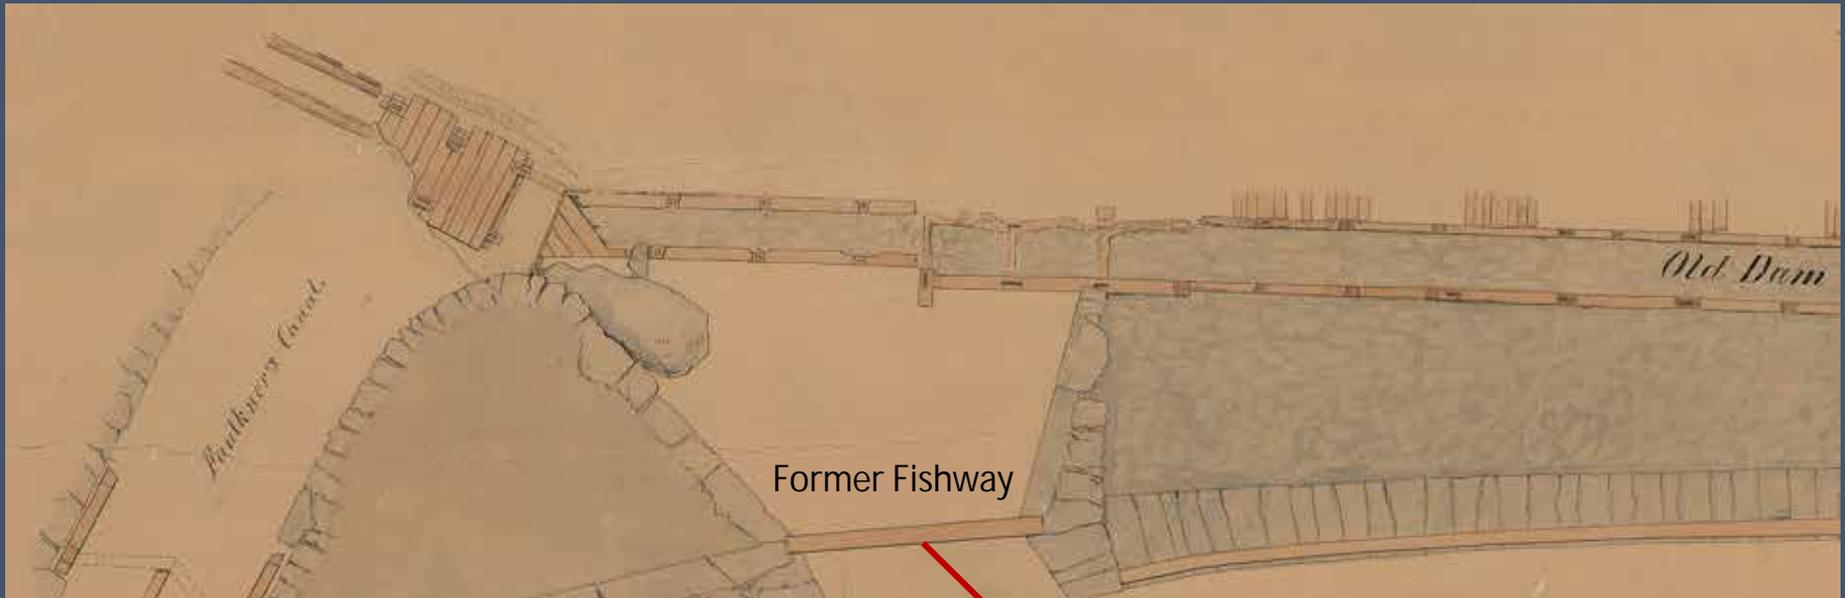
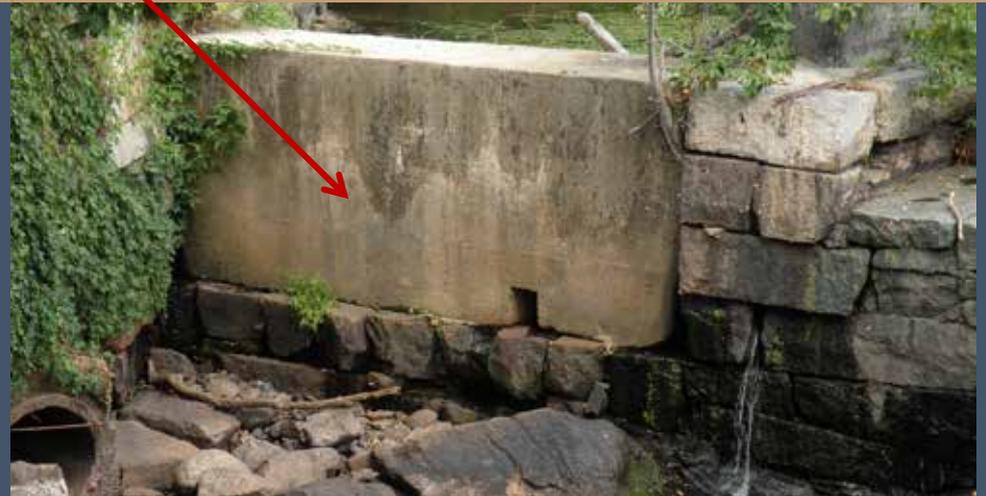
# TALBOT MILLS DAM – History

*"...so long as there shall be kept and upheld, a dam across Concord River, in the Town of Billerica...there shall be kept open at the usual place in said dam, a **sluice or passage way for fish** to pass up and down the river through said dam, from the first day of April to the twentieth day of May in each year..." (1820 Chap. 0070)*

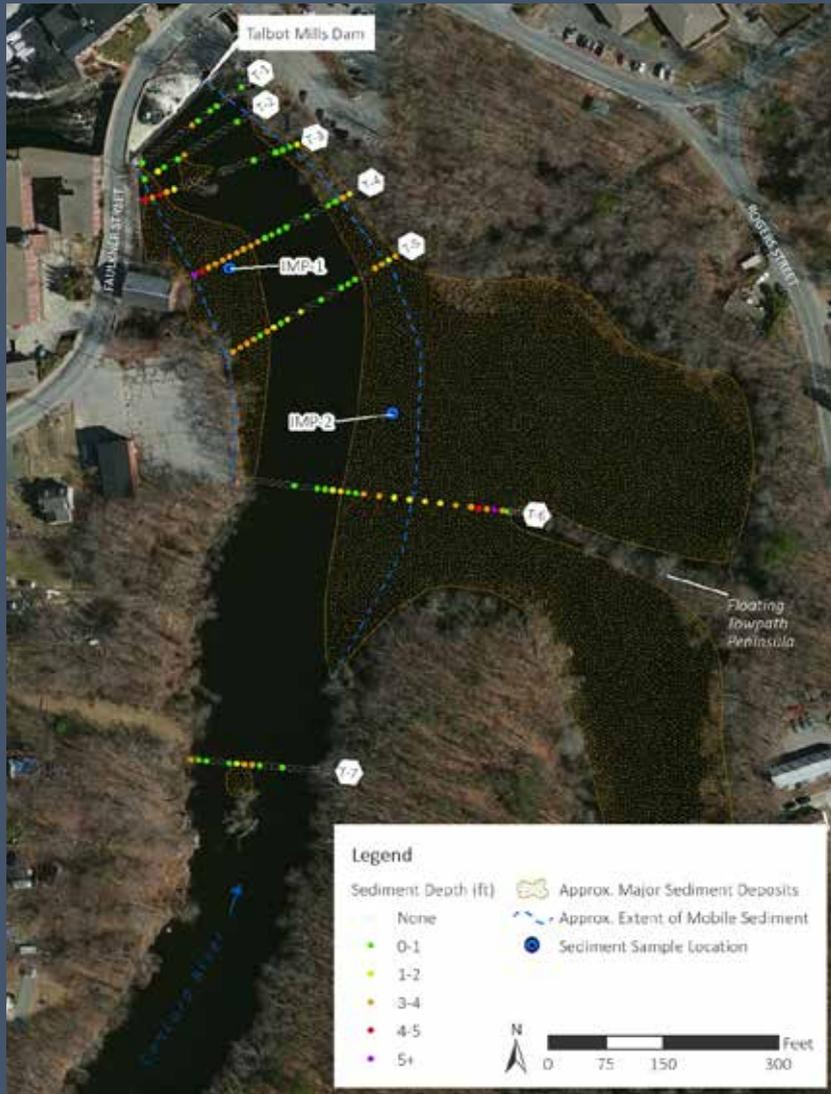
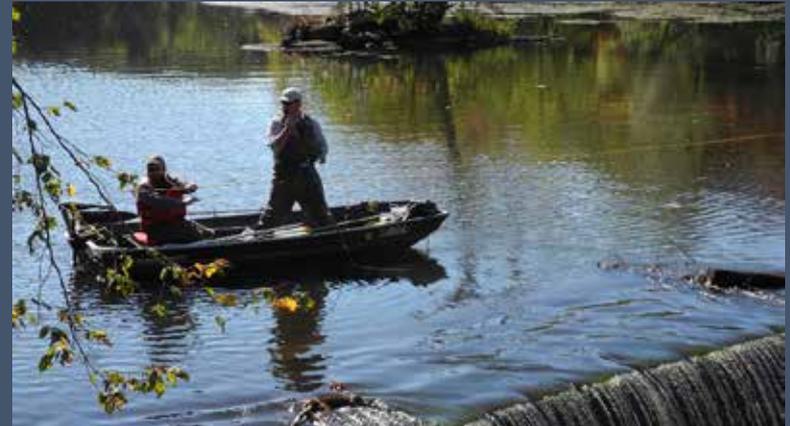
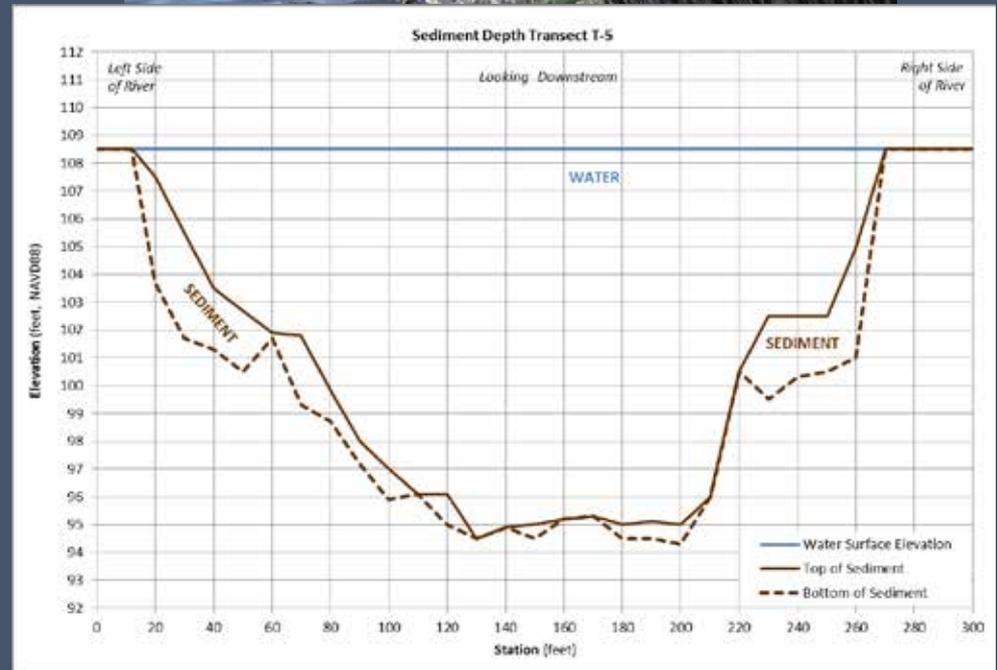
# FIELD DATA – Sediment Quantity

- Sediment quantity:
  - ~18,200 CY total sediment
  - ~9,500 CY mobile sediment
- Sediment quality:
  - Overall low pollutant concentrations

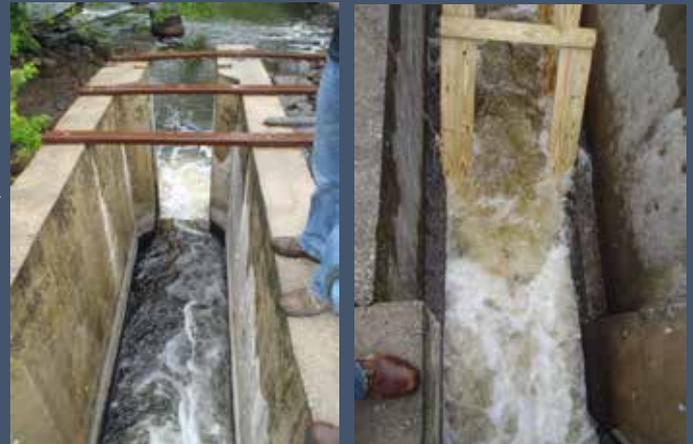
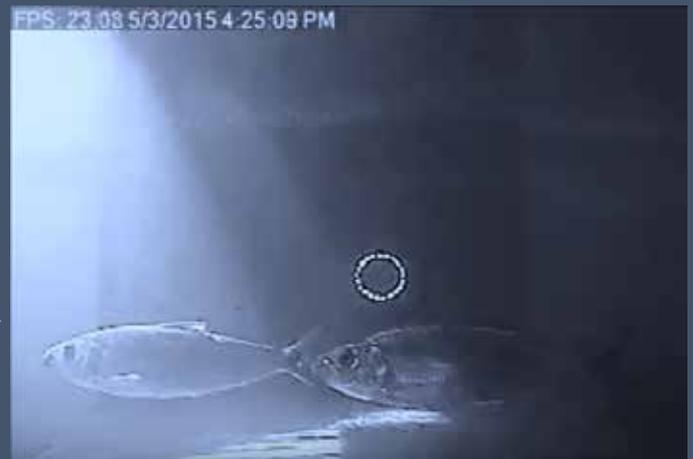
# CENTENNIAL FALLS DAM

- No Action
- Fishway Improvements (2A)
  - Fish ladder entrance
  - Tailwater staff gage
  - Trash rack
- Volunteer Coordination (2B)
  - Part-time coordinator
  - Training & observation (video monitoring system)
  - Education & outreach

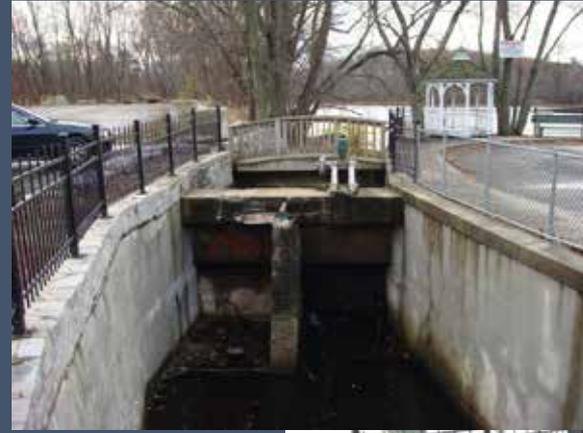
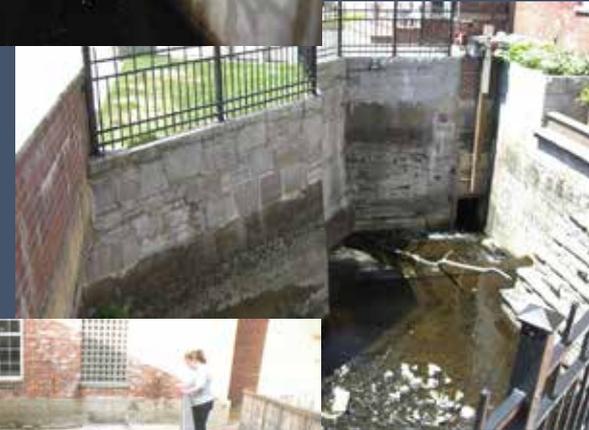
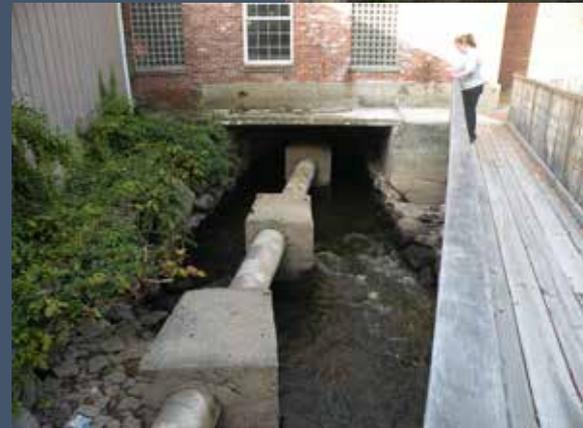
- No Action
- Technical Fishway (3A)
- Partial Dam Removal (3B)
- Other concepts considered:
  - Nature-like fishway
    - Rock ramp
    - Bypass channel
  - Sluiceway bypass channel

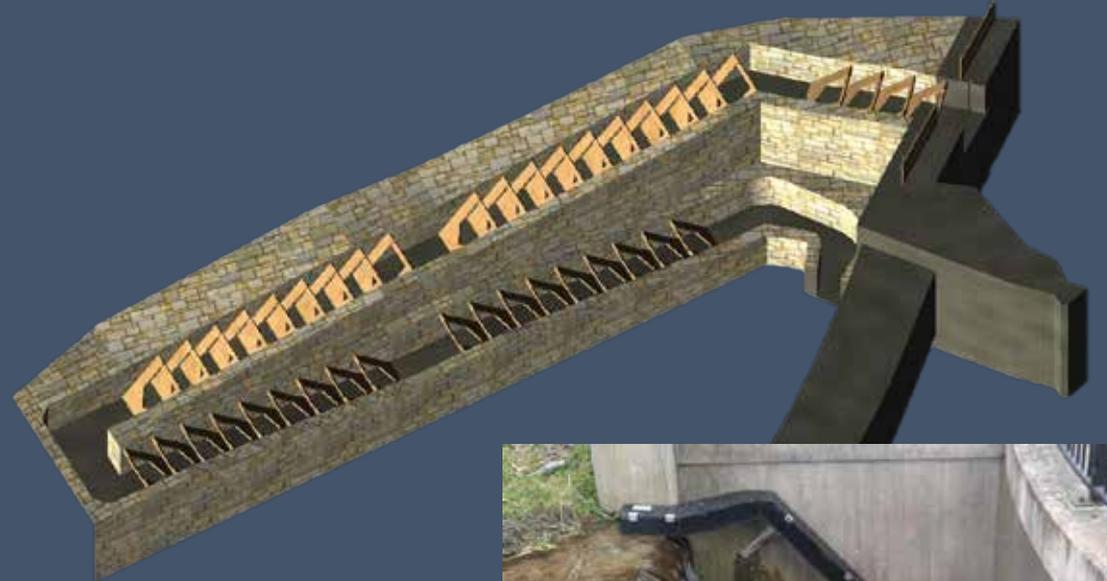
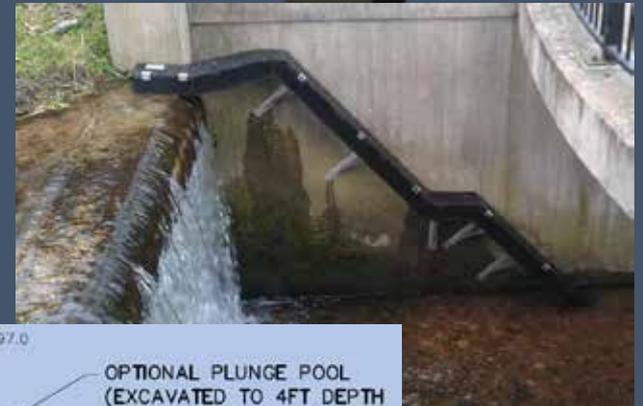
# TALBOT MILLS DAM – Technical Fishway

- Denil fish ladder
- Eel ramp
- Downstream passage notch & plunge pool
- Water controls (stoplogs, flashboards)

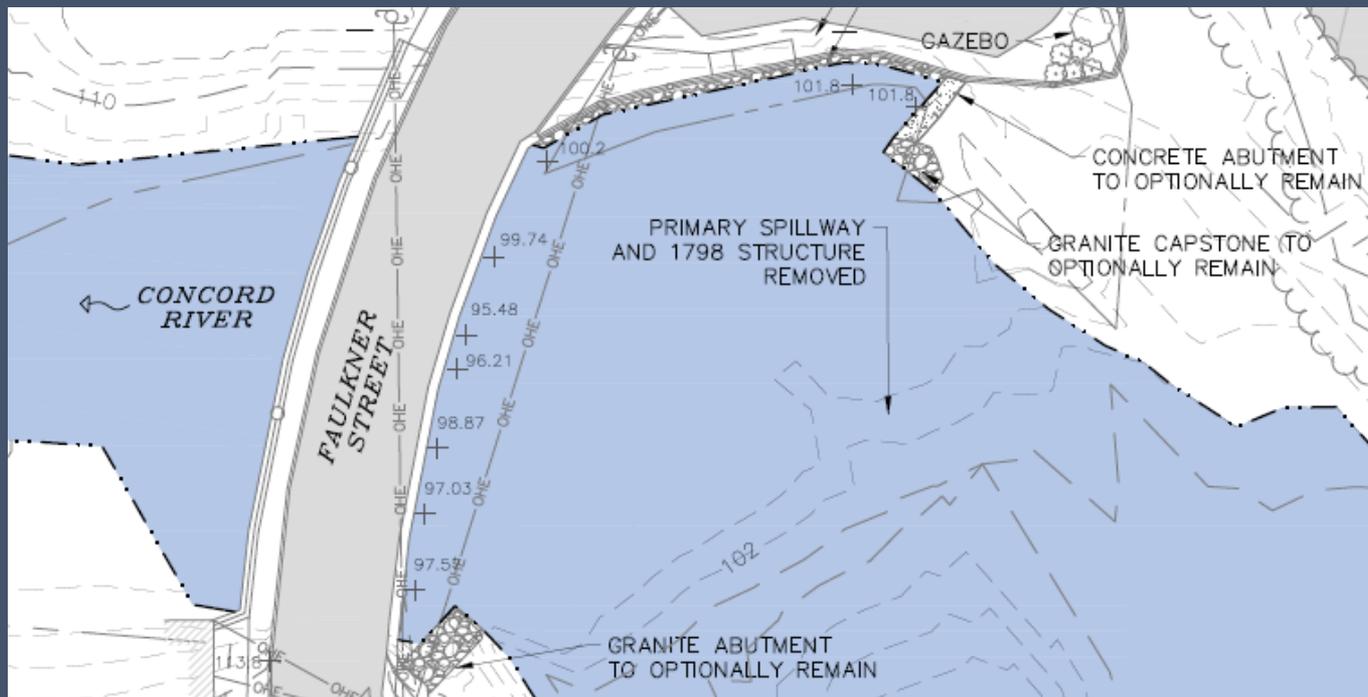
# TALBOT MILLS DAM – Dam Removal

- Removal of primary spillway & legacy dam
- One or both abutments could optionally remain
- Preliminary recommendation for instream sediment mgmt.

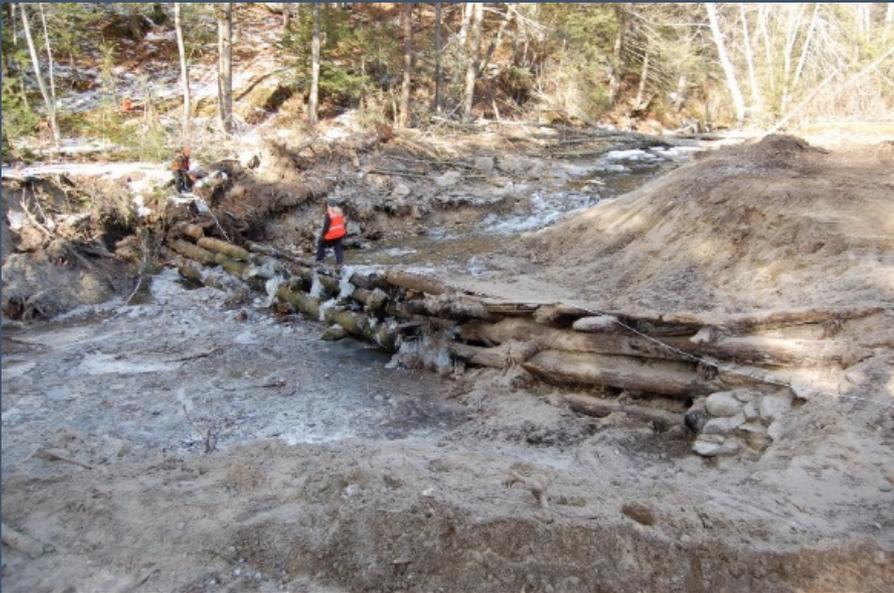
Archaeological monitoring and recordation in high sensitivity areas during construction, to identify and record any buried surviving components of the earlier dams and fishways.
