**Pre-Assessment Data Report  
Tank Barge DBL 152 Oil Discharge in Federal Waters,  
Gulf of Mexico**

**Cooperatively prepared by the  
National Oceanic and Atmospheric Administration and  
ENTRIX, Inc. (on behalf of K-Sea Transportation Partners LP)**

**January 9, 2009**

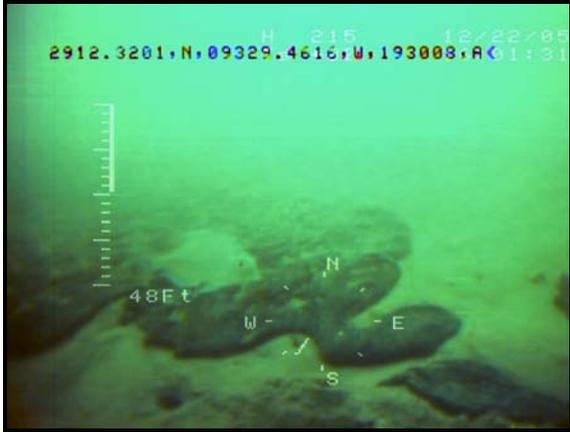
ROV video image of submerged oil from T/B DBL 152, 22 December 2005

Beginning in early December 2005, submerged oil identification was performed using a tethered ROV. The ROV contained a video camera allowing continuous imagery of the seafloor to be viewed in real-time and recorded. However, the ROV lacked precise positioning, so its exact location over the seafloor could only be estimated relative to the support vessel. The ROV was the primary means of verifying suspected submerged oil patches identified using alternative methods (e.g., side scan sonar). It was also used to systematically survey the bottom in a grid pattern in other areas. Approximately 85 ROV surveys were conducted, mostly west and west-northwest of the barge. ROV use was constrained by limited mobility, and at times, rough seas, poor visibility and oil fouling.

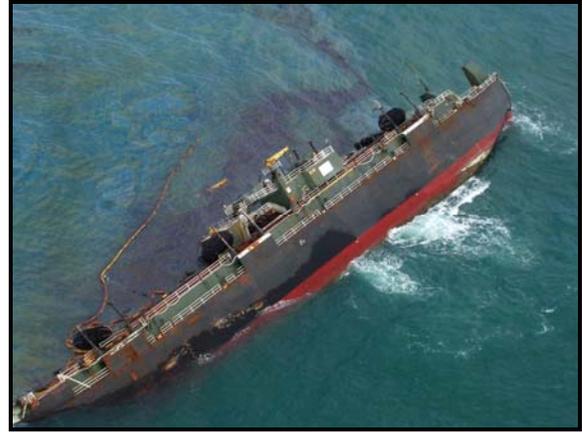
Disabled vessel before capsizing showing discharge of oil, November 2005

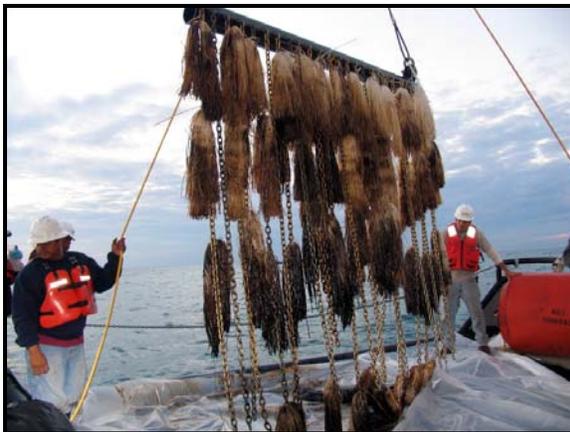
V-SORS Heavy chain drag used to detect submerged oil, December 2005

Two (2) versions of the V-SORS device were used for this incident. The original configuration, later called “V-SORS Heavy,” consisted of an 8-foot wide header beam constructed of heavy steel pipe trailing 25 8-foot long heavy-link chains to which six (6) to eight (8) viscous snare pompoms were attached along the length of every other chain (see Figure 2). Deployment and retrieval of V-SORS Heavy devices required a crane or other overhead lifting equipment.

Both V-SORS Heavy and V-SORS Light were towed across the seafloor along designated transects using GPS for navigation. At specified intervals, the V-SORS device was hoisted to the surface to inspect the pompoms. The amount of oil on the pompoms was visually assessed and a qualitative level of oiling (heavy, medium, light & very light) was assigned to the transect. A pictorial job aid was created to help ensure consistent classification of oiling levels on snares across multiple teams (See Figure 3). In addition, the composition of V-SORS survey teams remained as consistent as possible, also to promote uniformity in the results.

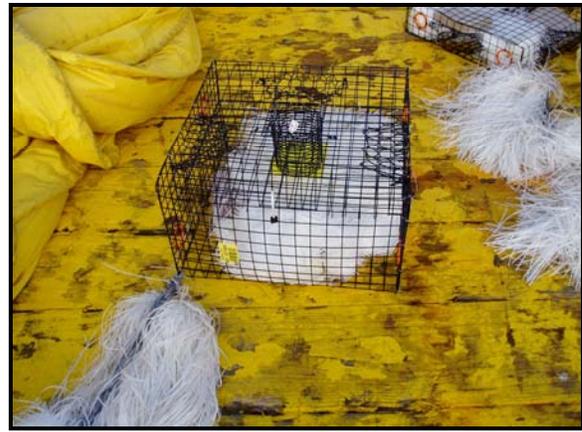
Crab pot sentinels used to detect submerged oil, December 2005

These devices initially consisted of snare on a rope with an anchor on one end and a buoy float on the other. Later iterations also included snare-filled crab pots positioned to rest on the bottom. These devices were deployed at specific locations for one or more days to detect submerged oil on the seafloor and suspended in the water column. Unlike V-SORS, stationary vertical snare samplers and snare sentinels provided a time-integrated assessment at a single location.

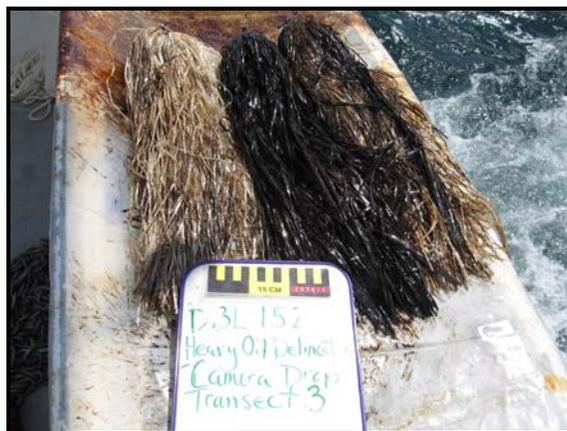
Oiled snares associated with a camera drop, September 2006

Two (2) additional surveys were performed in September 2006 to delineate the heavy oil patch identified during the mid-July 2006 LTM survey. These surveys also aimed to determine if the heavy oil was recoverable<sup>3</sup>, as well as “calibrate” the results of the V-SORS Light apparatus by visually characterizing submerged oil using divers and an underwater drop camera.

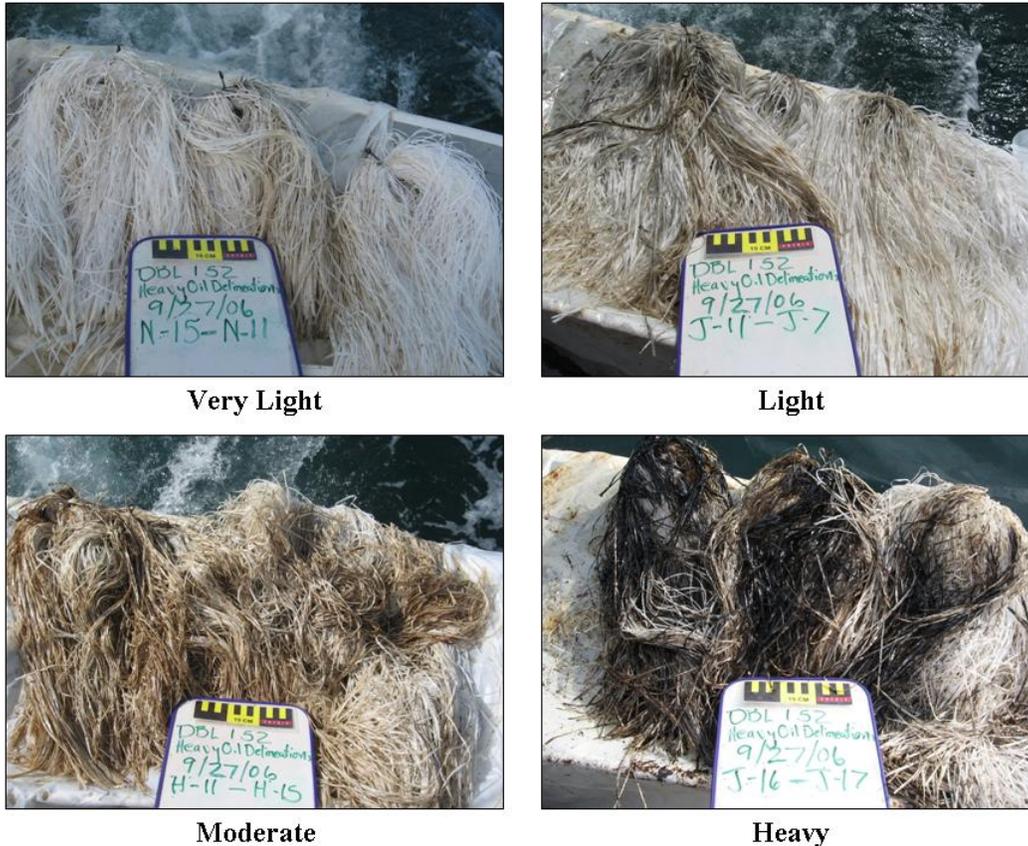
**Figure 3. Representative Examples of Qualitative Oiling Levels on V-SORS Light**

Due to operational constraints, a scaled-down version, known as “V-SORS Light,” was developed. The V-SORS Light device consisted of two 8-foot lengths of heavy-link chain each carrying three (3) snare pompoms attached to the end of a single rope. V-SORS Light were deployed and retrieved by hand often with two units simultaneously towed from opposite sides of a vessel.

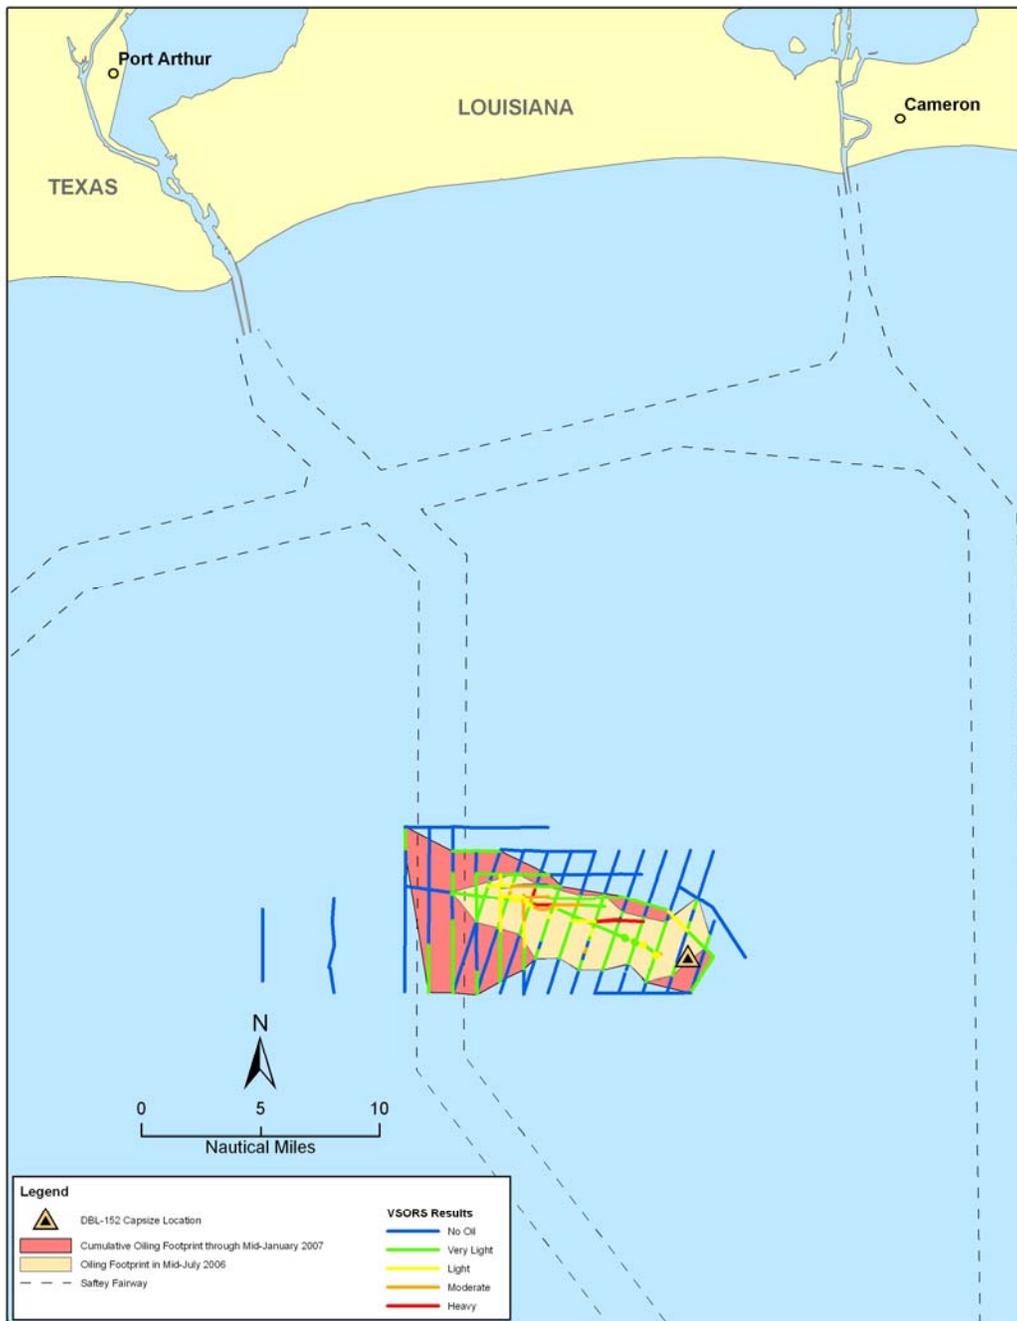
**Figure 4. Cumulative Extent of Submerged Oil Based on V-SORS Results during Response and Long-Term Monitoring**

Overall, oil has not been detected more than approximately 13 nm from the capsized location. The extent of the submerged oil field determined in mid-July 2006 was approximately  $26 \text{ nm}^2$ . Based on combined V-SORS results from the response and LTM, approximately  $53 \text{ nm}^2$ , cumulatively, were exposed to some degree of oiling from the time of the incident through mid-January 2007 (Figure 4). However, submerged oil did not occupy this entire area simultaneously. The size and location of the submerged oil field is subject to change pending further review of LTM data and estimation of future oil movement.

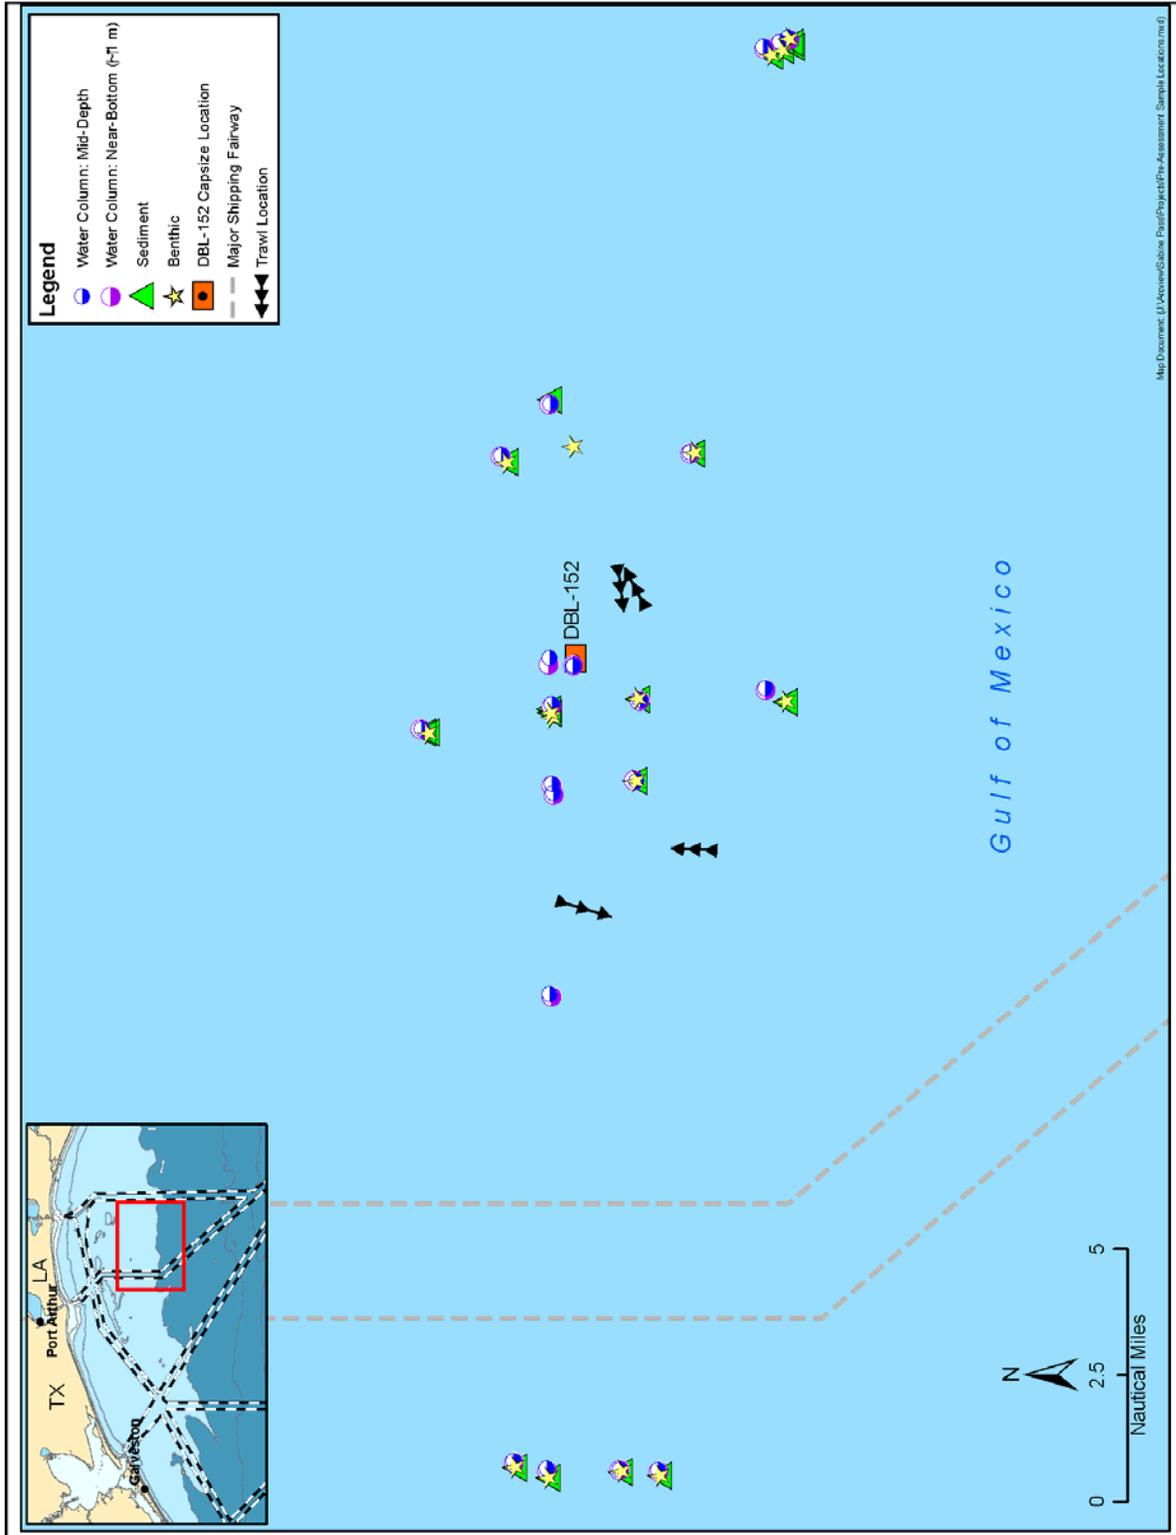
**Figure 5. Pre-Assessment Water Column, Sediment, Benthic and Trawl Sample Collection Locations**

Thirty-four surficial sediment samples consisting of the top two (2) to four (4) inches of sediment were collected during pre-assessment activities to evaluate the benthic invertebrate community in the affected area. These sediment samples were collected with Van Veen and ponar dredge-type samplers. Sample locations are shown in Figure 5.
