UNITED STATES COAST GUARD

INVESTIGATION INTO THE STRIKING OF SUBMERGED
OBJECTS BY THE TANK VESSEL

ATHOS I

IN THE DELAWARE RIVER ON NOVEMBER 26, 2004
WITH A MAJOR DISCHARGE OF OIL

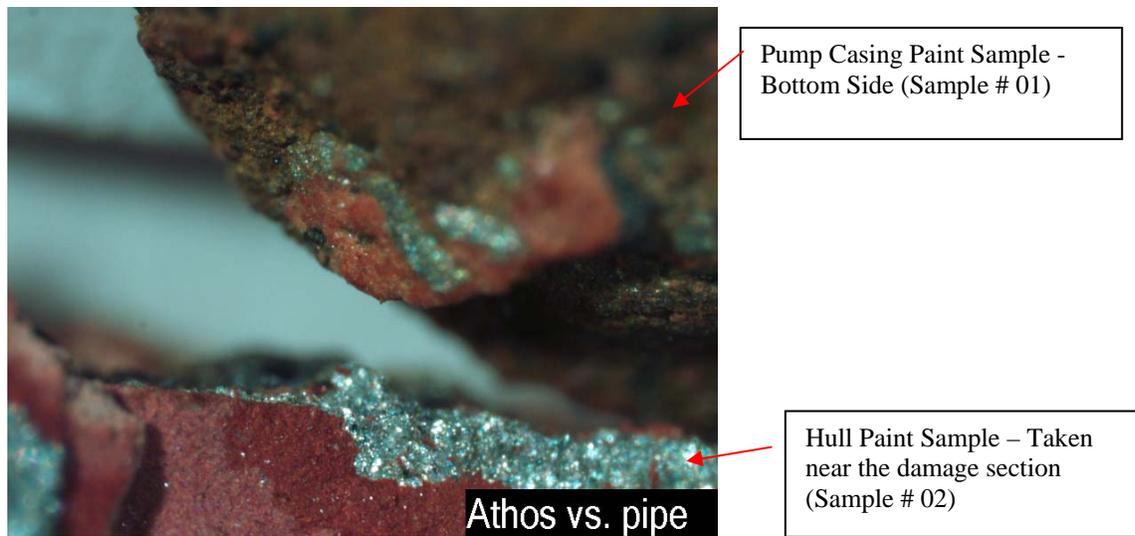
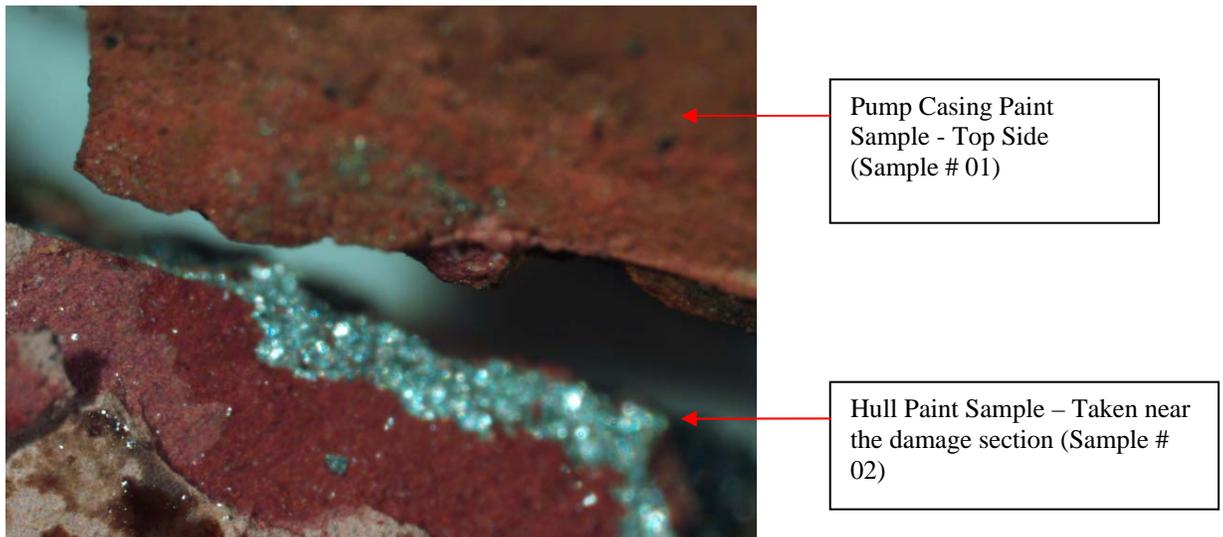
On the 6th of December 2004, Coast Guard investigators requested assistance from the Philadelphia City Crime Lab to conduct analysis on paint chips taken from the pump casing (sample # 01) and the T/V ATHOS I hull (sample # 02), to determine if the ATHOS I came into contact with the pump casing. Coast Guard investigators took the samples to the lab and met with Mr. Louis Szojka (Laboratory Program Scientist) who performed the analysis. At no time did the paint samples leave the sight or chain of custody of the Coast Guard investigators. Mr. Szojka used a microscope to analyze and compare the paint layers from the pump casing and the paint sample from the vessel's hull. Mr. Szojka stated "conditions are favorable for a match and warrant future testing on the samples." Mr. Szojka was able to provide a printout of the comparison between the two paint chips' samples.
